**Flood Control Project Maintenance  
Levee Inspections**

## Maintenance Issue Types Only, Levee Inspection Report By Mile - Spring 2020

### Reclamation District No. 0785 Driver

Waterway	Bank	Unit Miles	Inspection Start/End	Inspector
Unit No. 01 Sacramento River	Right	2.26	04/10/2020 04/10/2020	Zach Jojola

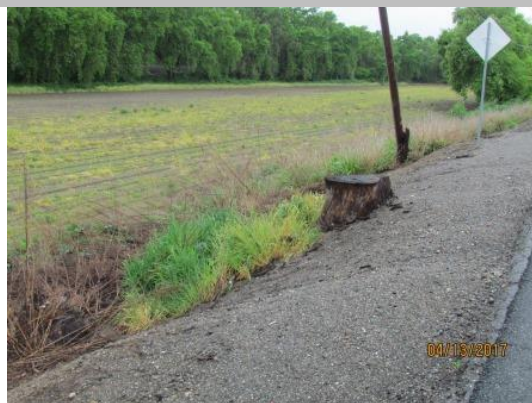
Photo 1 of 1 : SP\_2020\_RD0785\_185\_36\_20200228\_00021.jpg

LM Start	<b>0.28</b>	Rating **	N	Issue No.	<b>36</b>							
LM End	<b>0.28</b>	Issue Type +	Ma	Location *	LS							
Category	Earthen Levee		GPS Latitude/Longitude									
			Start	End								
Item	Trim / Thin Trees		38.658537 °	38.658537 °								
			-121.609675 °	-121.609675 °								
DWR ID	DWR_RD0785_01_s_2017_36											
Comment Code												
T5 : Tree stumps.												
Inspector Comment

View of stump on landside levee slope. Spring 2017.

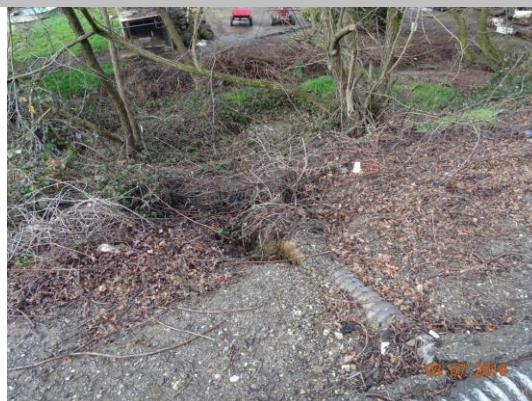
Photo 1 of 1 : SP\_2020\_RD0785\_185\_22\_20200228\_00014.jpg

LM Start	0.64	Rating **	M	Issue No.	22
LM End	0.64	Issue Type +	Ma	Location *	LS
Category	Earthen Levee			GPS Latitude/Longitude	
				Start	End
Item	Erosion / Bank Caving			38.654294 °	38.654294 °
				-121.605949 °	-121.605949 °
DWR ID	DWR_RD0785_01_s_2019_22				
Comment Code					
E2 : Schedule repair of erosion site prior to the next inspection.					
Inspector Comment					
Erosion around drainage pipe.

View of erosion on the landside slope. Spring 2019.

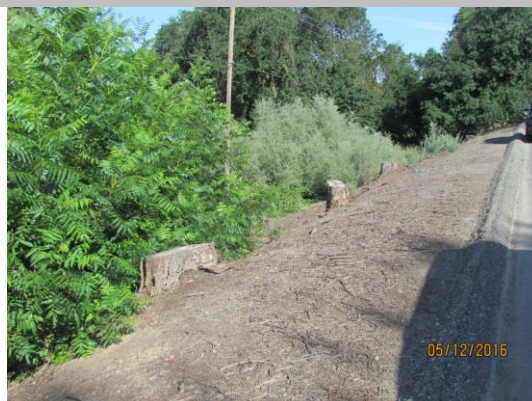
Photo 1 of 1 : SP\_2020\_RD0785\_185\_181\_20200228\_00024.jpg

LM Start	0.76	Rating **	N	Issue No.	181
LM End	0.76	Issue Type +	Ma	Location *	LS
Category	Earthen Levee			GPS Latitude/Longitude	
				Start	End
Item	Trim / Thin Trees			38.653003 °	38.653003 °
				-121.605061 °	-121.605061 °
DWR ID	DWR_RD0785_01_s_2014_181				
Comment Code					
T5 : Tree stumps.					
Inspector Comment

View of the tree stumps on the landward side of the levee looking upstream. Spring 2016.

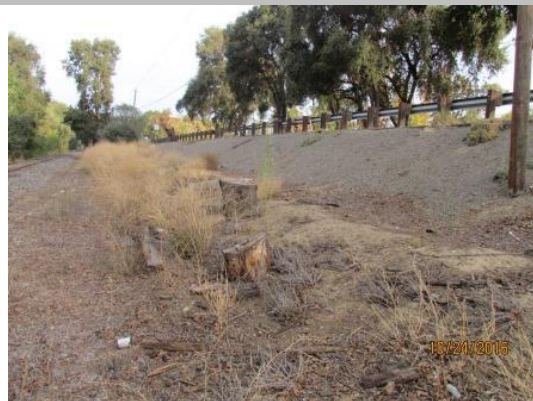
Photo 1 of 1 : SP\_2020\_RD0785\_185\_28\_20200228\_00017.jpg

LM Start	0.99	Rating **	N	Issue No.	28
LM End	0.99	Issue Type +	Ma	Location *	LS
Category	Earthen Levee			GPS Latitude/Longitude	
				Start	End
Item	Trim / Thin Trees			38.650055 °	38.650055 °
				-121.602752 °	-121.602752 °
DWR ID	DWR_RD0785_01_f_2016_28				
Comment Code					
T5 : Tree stumps.					
Inspector Comment

Two tree stumps near levee toe on landside. Fall 2016.

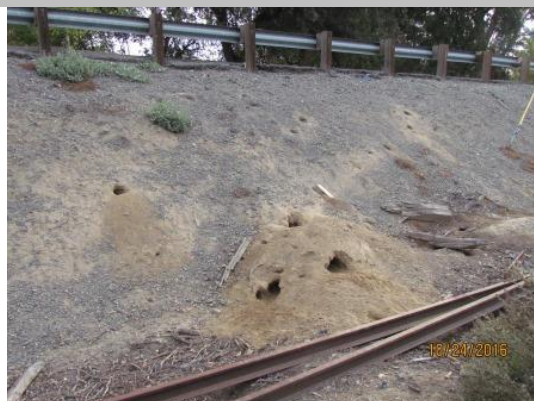
Photo 1 of 1 : SP\_2020\_RD0785\_185\_29\_20200228\_00018.jpg

LM Start	1.02	Rating **	M	Issue No.	29
LM End	1.02	Issue Type +	Ma	Location *	LS
Category	Earthen Levee			GPS Latitude/Longitude	
				Start	End
Item	Animal Control			38.649798 °	38.649798 °
				-121.602373 °	-121.602373 °
DWR ID	DWR_RD0785_01_f_2016_29				
Comment Code					
A3 : No rodents visible, but rodent burrows visible; need to backfill and compact or grout burrows.					
Inspector Comment					
Rodent holes on the landside slope.

View of rodent holes on LS slope. Fall 2016.

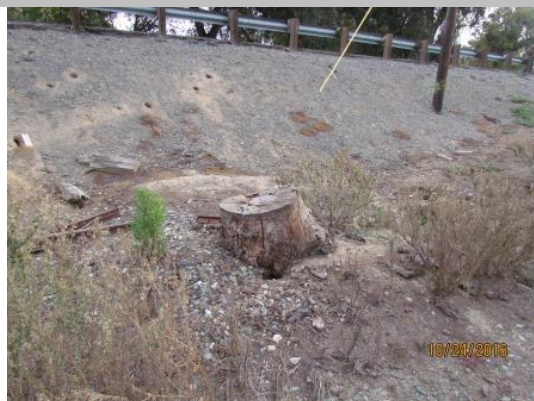
Photo 1 of 1 : SP\_2020\_RD0785\_185\_30\_20200228\_00020.jpg

LM Start	1.02	Rating **	N	Issue No.	30
LM End	1.02	Issue Type +	Ma	Location *	LS
Category	Earthen Levee			GPS Latitude/Longitude	
				Start	End
Item	Trim / Thin Trees			38.649775 °	38.649775 °
				-121.602363 °	-121.602363 °
DWR ID	DWR_RD0785_01_f_2016_30				
Comment Code					
T5 : Tree stumps.					
Inspector Comment					
Tree stump near levee toe

View of a stump near levee toe on landside. Fall 2016.

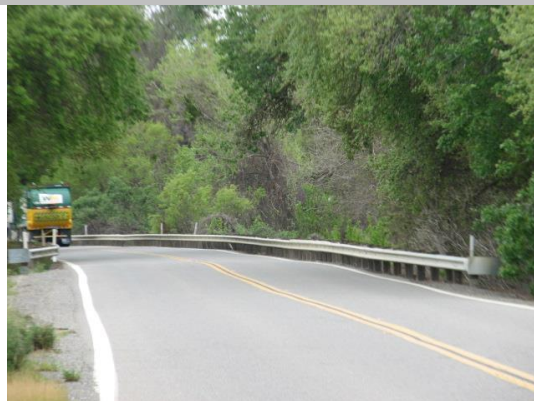
Photo 1 of 2 : SP\_2020\_RD0785\_185\_16\_20200228\_00011.jpg

LM Start	1.11	Rating **	M	Issue No.	16
LM End	1.21	Issue Type +	Ma	Location *	WS
Category	Earthen Levee			GPS Latitude/Longitude	
				Start	End
Item	Vegetation			38.648857 °	38.647805 °
				-121.601213 °	-121.600076 °
DWR ID	DWR_RD0785_01_f_2013_16				
Comment Code					
V2 : Remove the wild growth other than native grasses from the levee slopes.					
Inspector Comment

Brush and other vegetation partially blocks visibility. Spring 2014

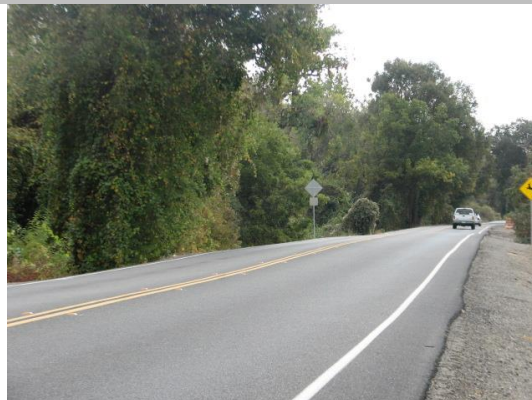
Photo 2 of 2 : SP\_2020\_RD0785\_185\_16\_20200228\_00010.jpg

LM Start	<b>1.11</b>	Rating **	M	Issue No.	<b>16 (cont)</b>
LM End	<b>1.21</b>	Issue Type +	Ma	Location *	WS
Category	Earthen Levee		GPS Latitude/Longitude		
			Start	End	
Item	Vegetation		38.648857 °	38.647805 °	
			-121.601213 °	-121.600076 °	
DWR ID	DWR_RD0785_01_f_2013_16

Brush and other vegetation partially blocks visibility or access to the levee slope. Fall 2013

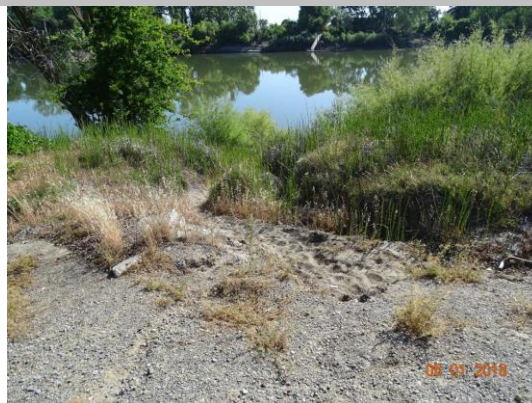
Photo 1 of 2 : SP\_2020\_RD0785\_185\_13\_20200228\_00007.jpg

LM Start	1.31	Rating **	M	Issue No.	13
LM End	1.31	Issue Type +	Ma	Location *	WS
Category	Earthen Levee			GPS Latitude/Longitude	
				Start	End
Item	Erosion / Bank Caving			38.646652 °	38.646652 °
				-121.598907 °	-121.598907 °
DWR ID	DWR_RD0785_01_s_2013_13				
Comment Code					
E2 : Schedule repair of erosion site prior to the next inspection.					
Inspector Comment					
Rills on the waterside slope.

View of runoff on the waterside slope. Spring 2018.

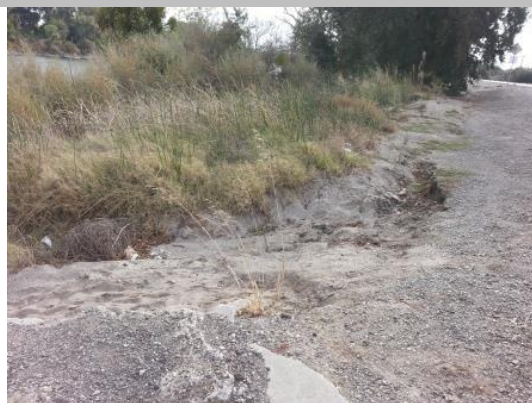
Photo 2 of 2 : SP\_2020\_RD0785\_185\_13\_20200228\_00008.jpg

LM Start	<b>1.31</b>	Rating **	M	Issue No.	<b>13 (cont)</b>
LM End	<b>1.31</b>	Issue Type +	Ma	Location *	WS
Category	Earthen Levee			GPS Latitude/Longitude	
				Start	End
Item	Erosion / Bank Caving			38.646652 °	38.646652 °
				-121.598907 °	-121.598907 °
DWR ID	DWR_RD0785_01_s_2013_13

View of the runoff on the waterside slope. Fall 2016.

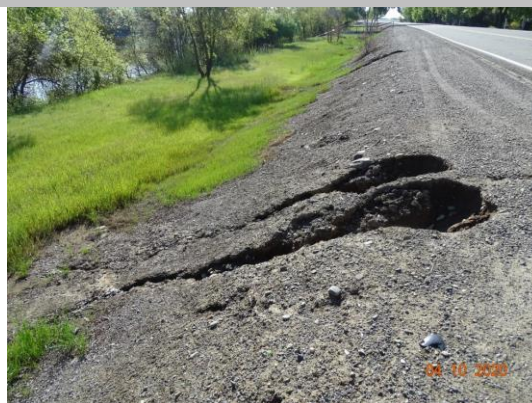
Photo 1 of 1 : SP\_2020\_RD0785\_185\_55\_20200504\_00037.jpg

LM Start	1.50	Rating **	M	Issue No.	55
LM End	1.51	Issue Type +	Ma	Location *	WS
Category	Earthen Levee			GPS Latitude/Longitude	
				Start	End
Item	Erosion / Bank Caving			38.644482 °	38.644349 °
				-121.596640 °	-121.596506 °
DWR ID	DWR_RD0785_01_f_2017_55				
Comment Code					
E2 : Schedule repair of erosion site prior to the next inspection.					
Inspector Comment					
Runoff on waterside slope.

View of rills on the waterside slope. Spring 2020.

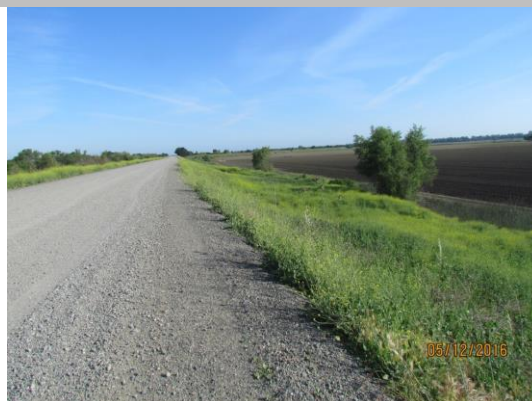
Photo 1 of 1 : SP\_2020\_RD0785\_186\_280\_20200228\_00005.jpg

LM Start	0.38	Rating **	A/W	Issue No.	280
LM End	0.38	Issue Type +	Ma	Location *	LS
Category	Earthen Levee			GPS Latitude/Longitude	
				Start	End
Item	Slope Stability			38.636265 °	38.636265 °
				-121.617422 °	-121.617422 °
DWR ID	DWR_RD0785_02_s_2015_280				
Comment Code					
S1 : Repair slope instability.					
Inspector Comment					
Seems to be a bulge at the toe of the levee. Recommend monitoring.

View of the slope stability on the landward side of the levee looking upstream. Spring 2016.

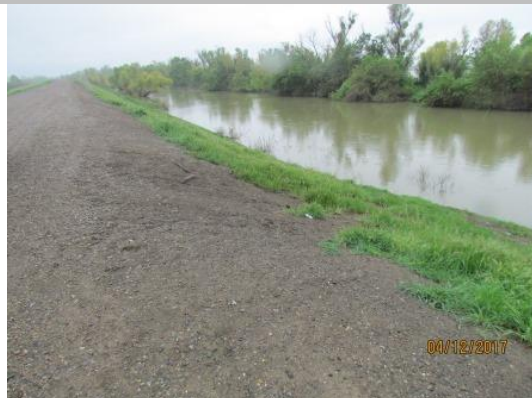
Photo 1 of 1 : SP\_2020\_RD0785\_186\_24\_20200228\_00004.jpg

LM Start	1.52	Rating **	M	Issue No.	24
LM End	1.52	Issue Type +	Ma	Location *	WS
Category	Earthen Levee			GPS Latitude/Longitude	
				Start	End
Item	Slope Stability			38.621694 °	38.621694 °
				-121.607610 °	-121.607610 °
DWR ID	DWR_RD0785_02_s_2017_24				
Comment Code					
S2 : Repair the levee slope damaged by foot traffic and prevent access where possible.					
Inspector Comment					
Footpath for environmental access site. There is a noticeable dip on the waterside slope.

View of slope stability on waterside levee slope. Spring 2017.

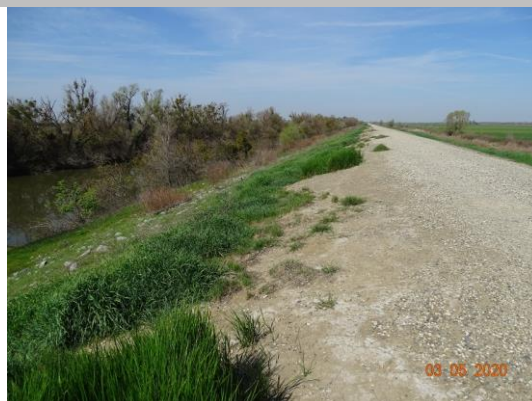
Photo 1 of 1 : SP\_2020\_RD0785\_186\_5\_20200313\_00008.jpg

LM Start	1.79	Rating **	M	Issue No.	5
LM End	3.24	Issue Type +	Ma	Location *	WS
Category	Earthen Levee			GPS Latitude/Longitude	
				Start	End
Item	Vegetation			38.618239 °	38.600392 °
				-121.605002 °	-121.591049 °
DWR ID	DWR_RD0785_02_s_2020_5				
Comment Code					
V1 : Control annual grass and weeds on the levee slopes and easements.					
Inspector Comment

View of vegetation on the waterside slope. Spring 2020.

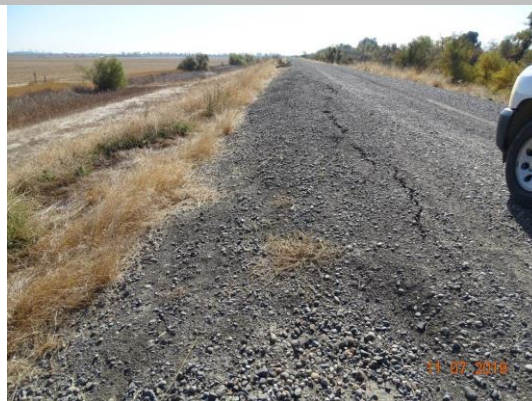
Photo 1 of 1 : SP\_2020\_RD0785\_186\_10\_20200228\_00001.jpg

LM Start	1.85	Rating **	M	Issue No.	10
LM End	1.86	Issue Type +	Ma	Location *	LS
Category	Earthen Levee			GPS Latitude/Longitude	
				Start	End
Item	Cracking			38.617562 °	38.617421 °
				-121.604431 °	-121.604321 °
DWR ID	DWR_RD0785_02_f_2019_10				
Comment Code					
CR1 : Monitor and have inspected by geotechnical engineer.					
Inspector Comment					
Appears to be a 100' longitudinal crack that shows some settlement on the landside shoulder. Recommend having the area inspected by a geotech.

View of cracking and settlement on the crown and landside shoulder. Fall 2019.

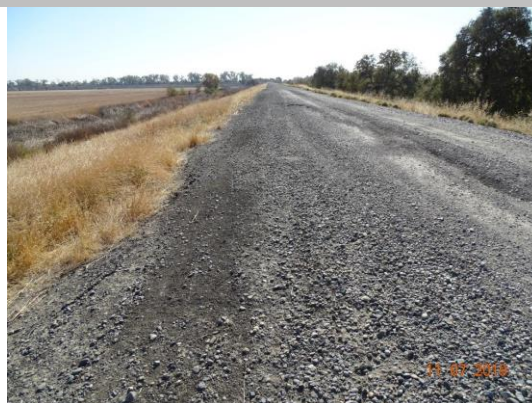
Photo 1 of 1 : SP\_2020\_RD0785\_186\_11\_20200228\_00002.jpg

LM Start	2.82	Rating **	M	Issue No.	11
LM End	2.83	Issue Type +	Ma	Location *	LS
Category	Earthen Levee			GPS Latitude/Longitude	
				Start	End
Item	Cracking			38.605597 °	38.605436 °
				-121.595097 °	-121.594980 °
DWR ID	DWR_RD0785_02_f_2019_11				
Comment Code					
CR1 : Monitor and have inspected by geotechnical engineer.					
Inspector Comment					
Appears to be a 100' longitudinal crack that shows some settlement on the landside shoulder. Recommend having the area inspected by a geotech.

View of cracking and settlement on the crown and landside shoulder.  
Fall 2019.
